CC3100 SimpleLink™ Wi-Fi® Network Processor and Internet-of-Things Solution for MCU Applications

Software Development Kit (SDK) v1.2.0 Release Notes

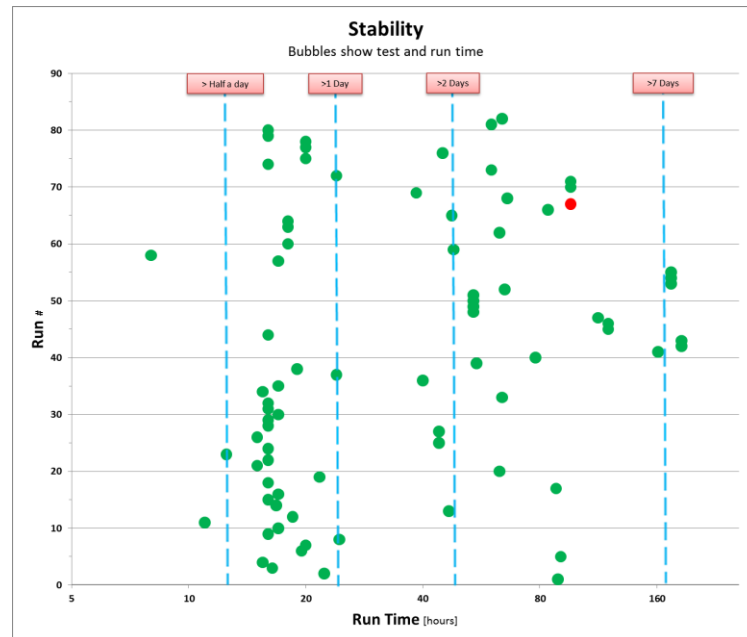
6.1.3 Stability

- STA was kept running at different traffic scenarios in open AIR for long durations.
 - Green Dot - STA was stopped after a set time
 - The Failure tests (red dot) is representing TCP Tx with 163Byte payload in congested environment, the test fail due to socket disconnect after 67Hours (3 other instances passed >70hours)
